TECHNICAL REPORT ARLCD-TR-80006

## M203 PROPELLING CHARGE RESIDUE INVESTIGATION PART I

JANUARY 1981

US ARMY ARMAMENT RESEARCH AND DEVELOPMENT COMMAND  
LARGE CALIBER  
WEAPON SYSTEMS LABORATORY  
DOVER, NEW JERSEY

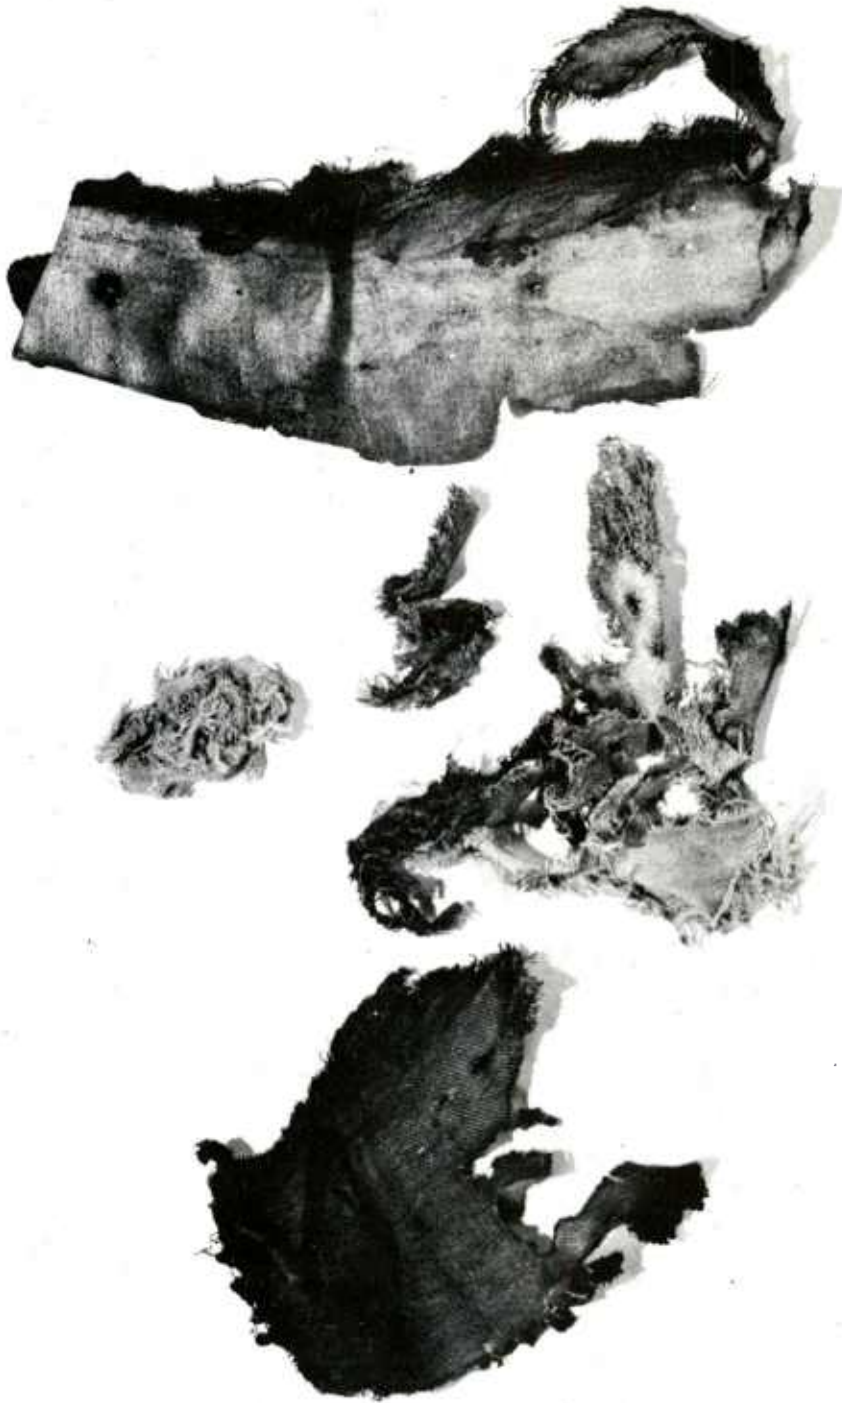
Figure 3. Typical example of residue resulting from safety testing

In the July 1978 safety test, 280 rounds, conditioned at both hot and cold temperatures, were fired, and the residue occurred during the last 8 of the group of 48 rounds being fired after conditioning and after subjection to transportation/vibration tests at 63°C. Typical examples of the residue observed are shown in figure 3.

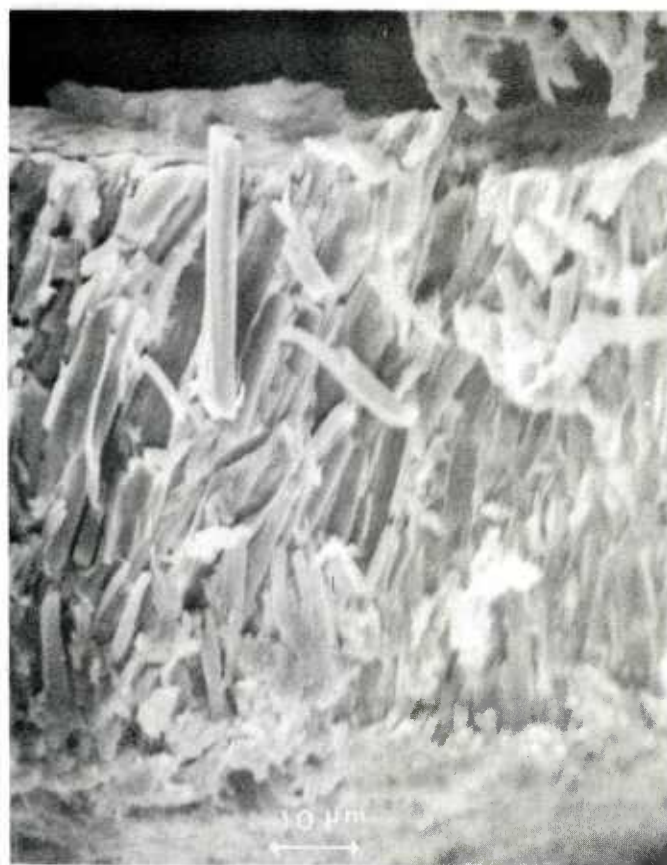
Figure B-3. SEM of M30A1 propellant lot E2 at 1000X magnification and 20 KV
